# Report on Flood Risk in the South Marston Brook Area following the 2023 storms

Compiled by South Marston Parish Council

November 2023

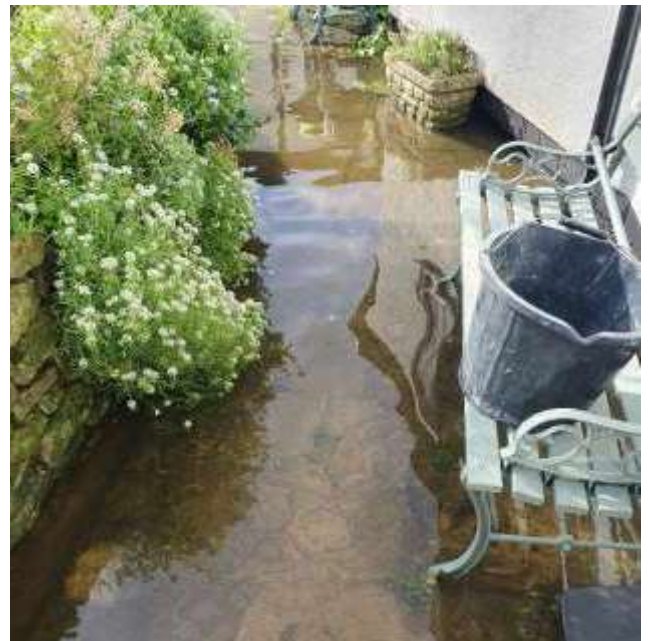
- South of the A420 at White Cottage on Shrivenham Road relates to a different part of the River Cole system. The fields mainly drain to the River Cole. However, a significant amount of water also goes north and collects in the line of the old canal parallel to the A420 which runs behind the housing.
- The resident says they were very close to having water inside the house as happened in 2007. They managed to pump it away from the back door which is close to the old canal but it came very close. If the water table gets too high, it comes up through the floor.

They worked hard to keep the canal culvert as clear as they could by pulling out branches and digging trenches so water overflowing into it from the fields could get away.

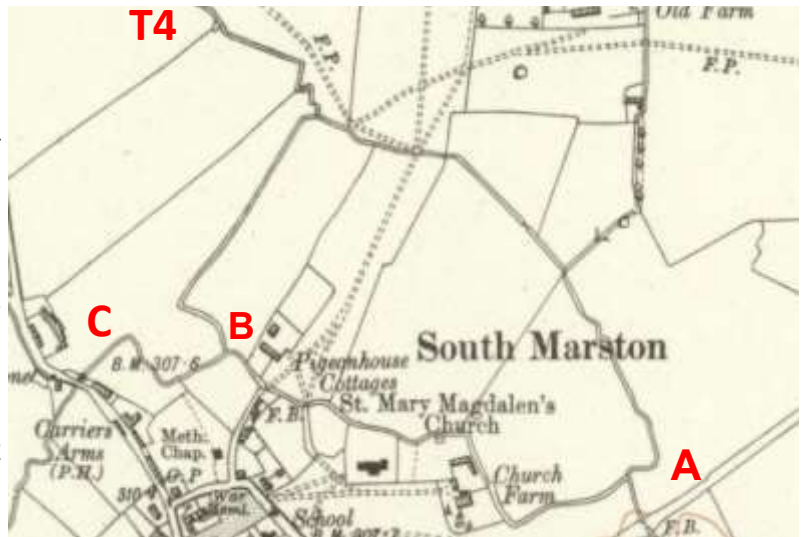
A complex ditch network is evident at the junction of the tributaries east of the village, seen here on a 1925 historic map, which is consistent with the official EA Surface Water flood map of the area.

From the top of the map, there are two branches taken by T4. The first goes straight on to join South Marston Brook at point A on Nightingale Lane. The second route takes a sharp right hand turn down to just upstream of the Chapel Lane bridge (point B) where it joins the main Brook coming from point C.

Over the years, the 'straight-on' branch of T4 has become almost entirely blocked due to lack of ditch maintenance. The water now mainly flows along the right turn towards Chapel Lane bridge, increasing the risk to the Chapel Lane and Church Farm groups of houses.

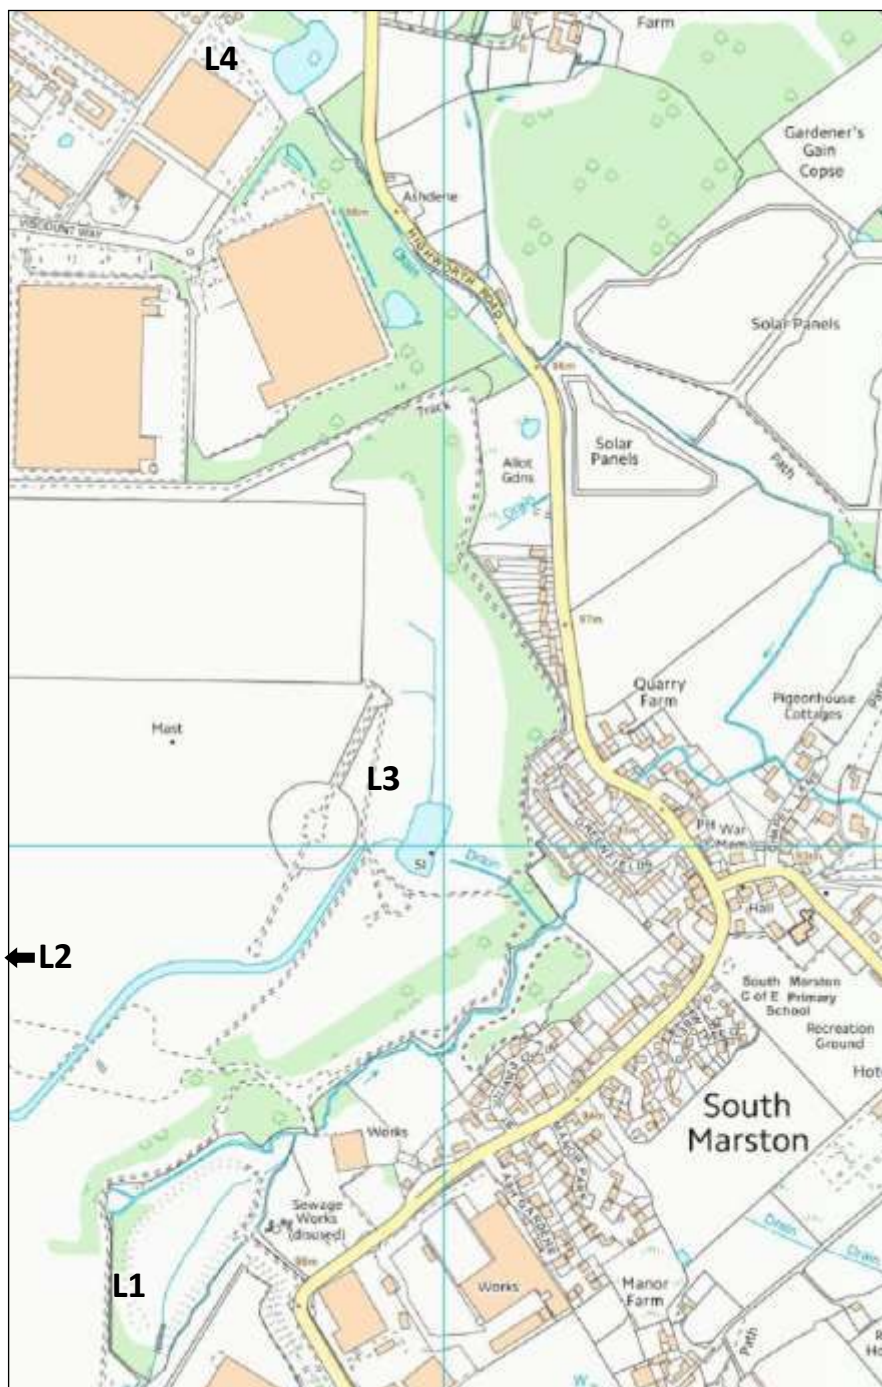
Regular reports have been given to the Borough by the owner's agents, but there is no section that relates to the lagoon. The Borough Drainage Engineer has told us that it has become silted and that he will ask the owners to arrange for this to be cleared and for future reports to include the lagoon.

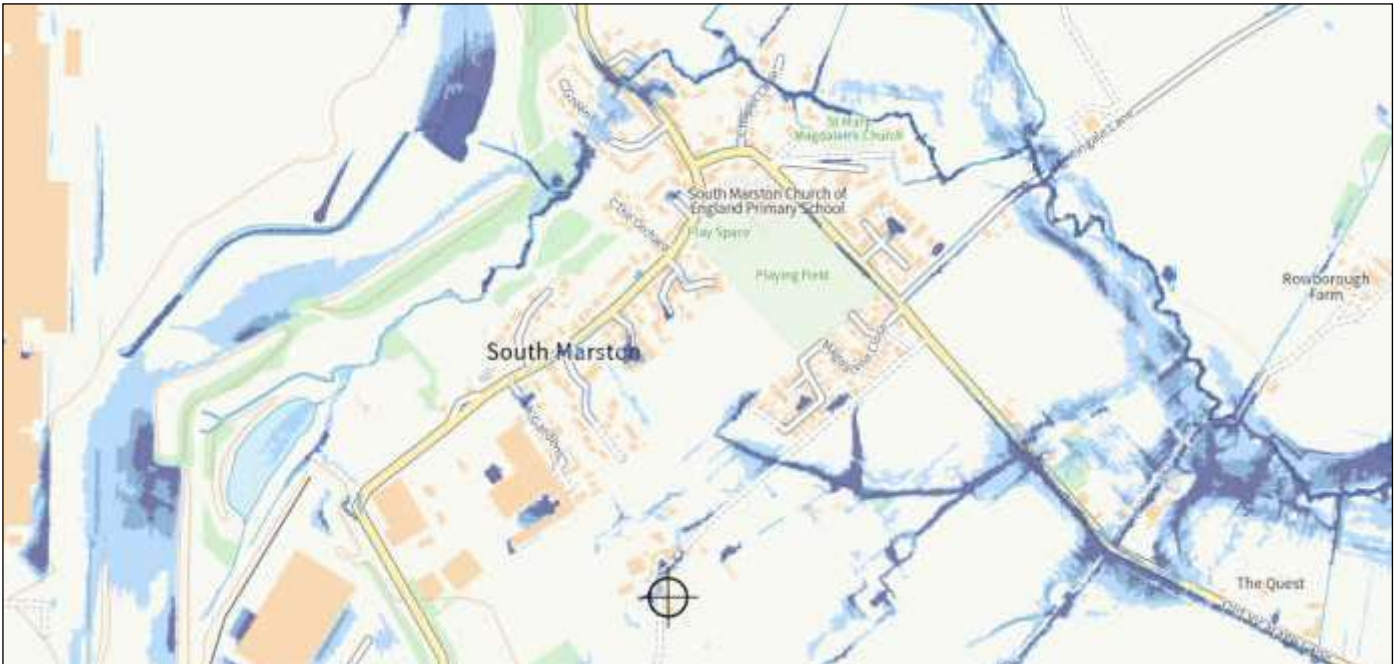
Water coming from the SBC storage lagoon behind the Keypoint site combines with the flow from the north (Honda/Panettoni site) via Tributaries T1, T2 and T3 to deliver surface water to the entrance of the Greenfields culvert. A significant proportion of the 53 village houses which suffered an ingress of water in the 2007 storms are located in Greenfields and Highworth Road beyond.

The entrance to the Greenfields culvert during storm Babet is shown on the right.

The flow came to about 250mm above the pipe entrance.

**Summary :** The cause of flooding is the peak water flow under the road. Possible solutions should focus on reducing the peak i.e. looking to increase storage capacity upstream. Development of the Panettoni site involves creating significant additional storage prior to the water flow being released into the Brook. However, increasing, or even just restoring the storage capacity of the SBC lagoon (which is not currently inspected or maintained) may also reduce peak flow downstream.

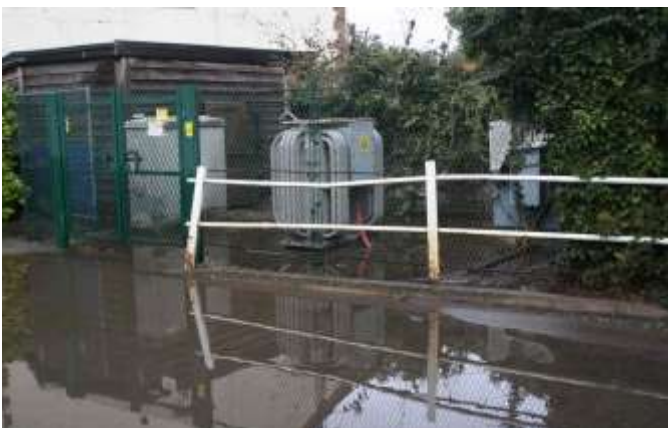
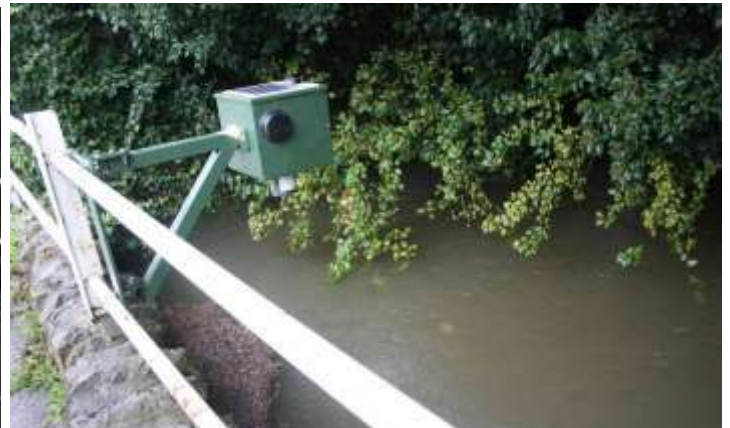
The photo (below left) shows the electrical substation at the point the watercourse emerges into the open after passing under Greenfields and Highworth Road.

The water came up to above the lower level of the bridge stonework by the water level sensor (bottom right).

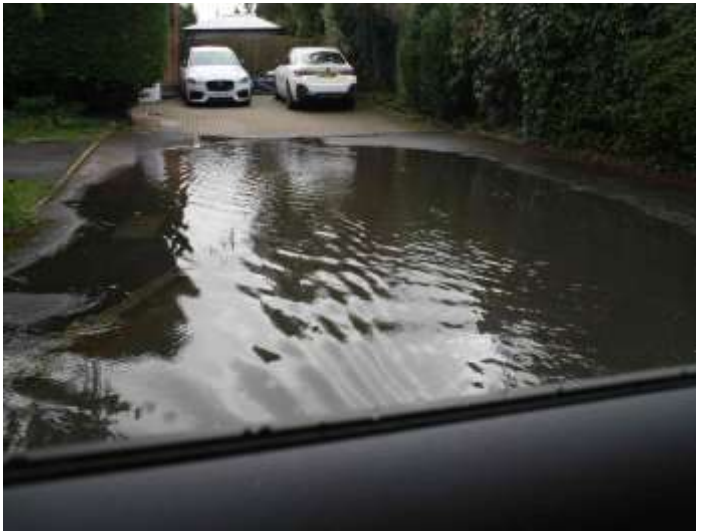
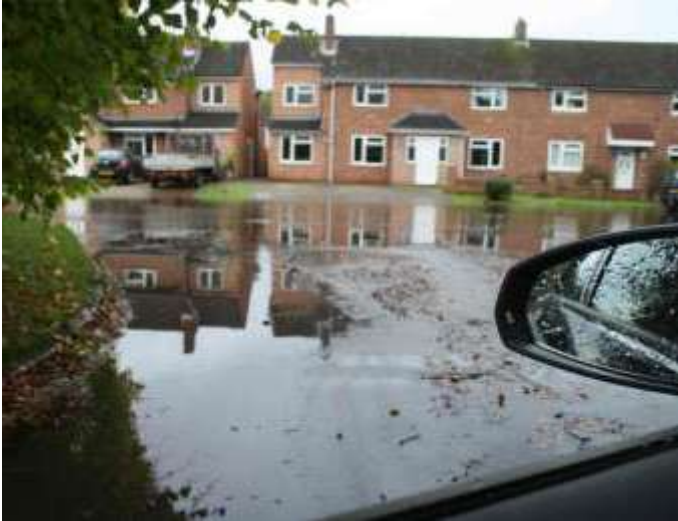
**Byron Court** was flooded with the water lapping up to the drives of the houses (right).

The photo below is from Byron Court looking out across the Highworth Road

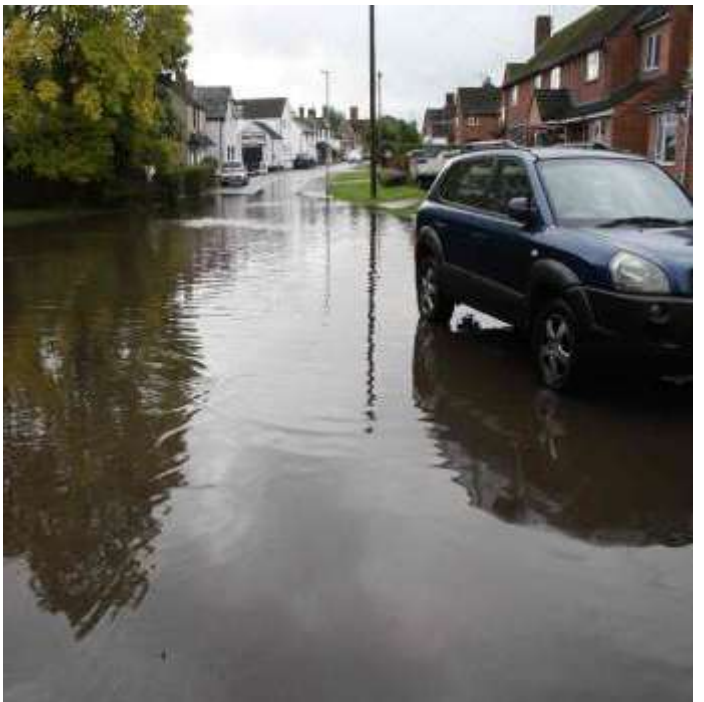
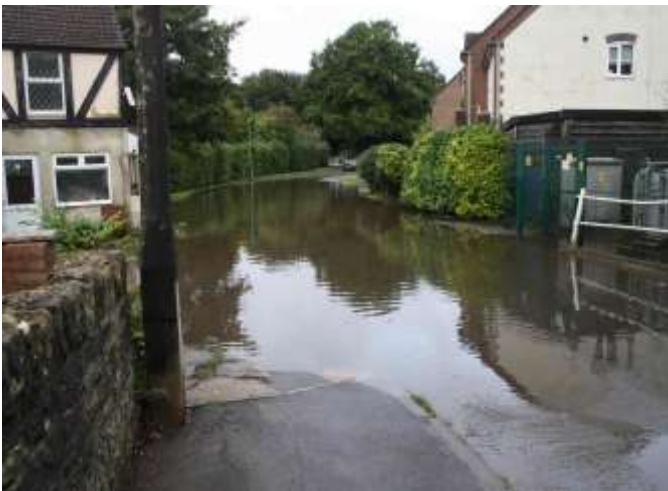
Looking from the bridge towards the **Carriers Arms**, it is virtually impassable (right). We had carers visiting the elderly abandoning their vehicle to wade barefoot into the **Quarrybrook** estate to the north.

The former Post Office & shop (left) had some water ingress on the ground floor and one car trying to get through had to be abandoned on the far side.

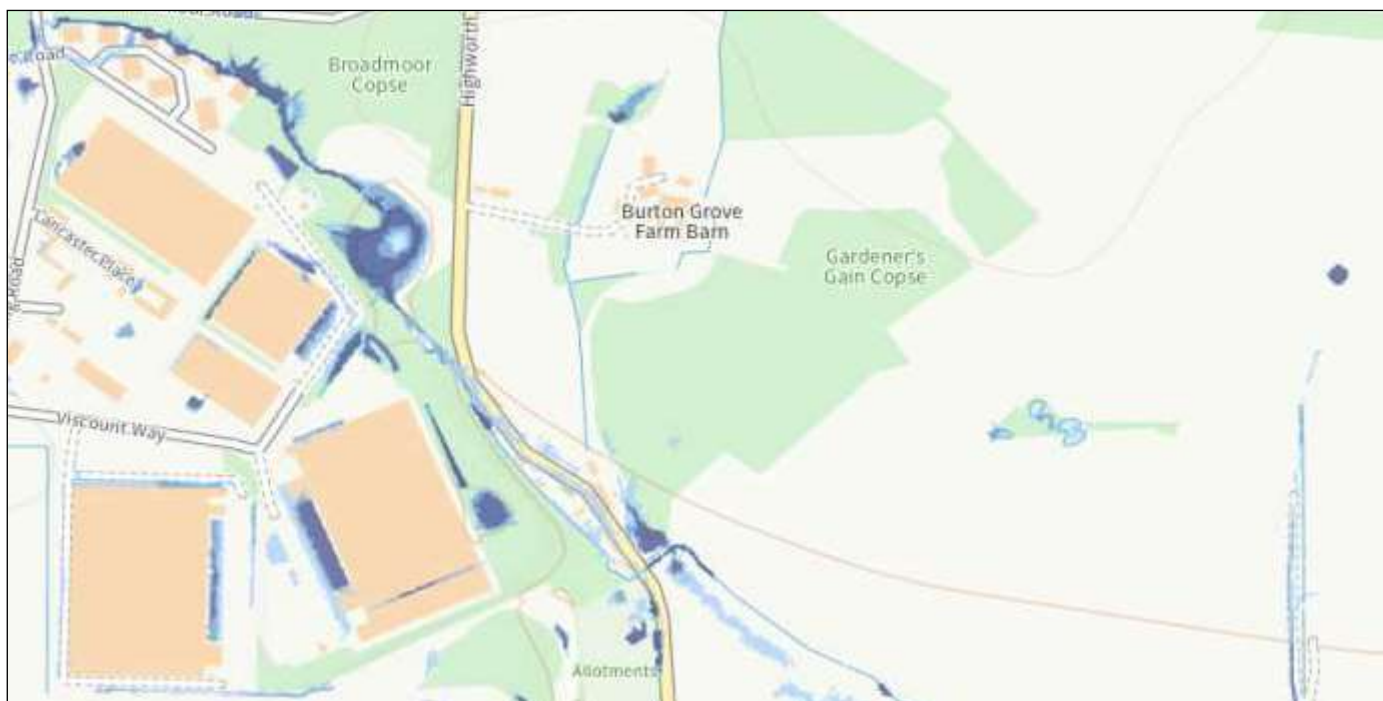
This stretch of road was impassable for most traffic. The 'Bends' dwellings experience floodwater both front and back of their properties. On the western side, flooding comes from storage ponds at South Marston Park. Surface water flows downhill to the gardens of housing on the western side of the 'Bends'. At the same time, surface water is also travelling downhill from the fields between South Marston and the road to Sevenhampton to reach the gardens of the 'Bends' housing on the eastern side. Worryingly, from the Supermarine turn, the roadway surface itself acts as a conduit for surface water, speeding up downhill until it reaches the 30 mph limit sign. At the 'Bends', this water is trapped by dwellings and buildings fronting straight onto the road, flooding the whole length of the built up area. At the southern end, the watercourse from South Marston Park passes under Highworth Rd to join the flooded gardens and fields on the eastern side of the road. Ditches and culverts are not adequate to carry the peak surface water flow away to the southeast.

Storm water from peak rainfall will flow downhill unless there is adequate storage capacity in lagoons and ditches to hold it back. The topography of the 'Bends' area means that water will collect on the road carriageway between the houses that border the road. If the upstream SM Park lagoon was dredged to restore or possibly even enhance its capacity, and was thereafter maintained, it would reduce the peak flow volume and speed of surface water in future rain events.

The flow of water on the carriageway down the hill from the Supermarine turn could be reduced if it was re-directed into adequate roadside ditches on the eastern side of the road. The Borough's Community Action Plan matrix also identified a cause of the road flooding was that some property owners who front onto the road had done works affecting roadside ditches in breach of planning permission. This has not been remedied despite apparent reference to Planning Enforcement.

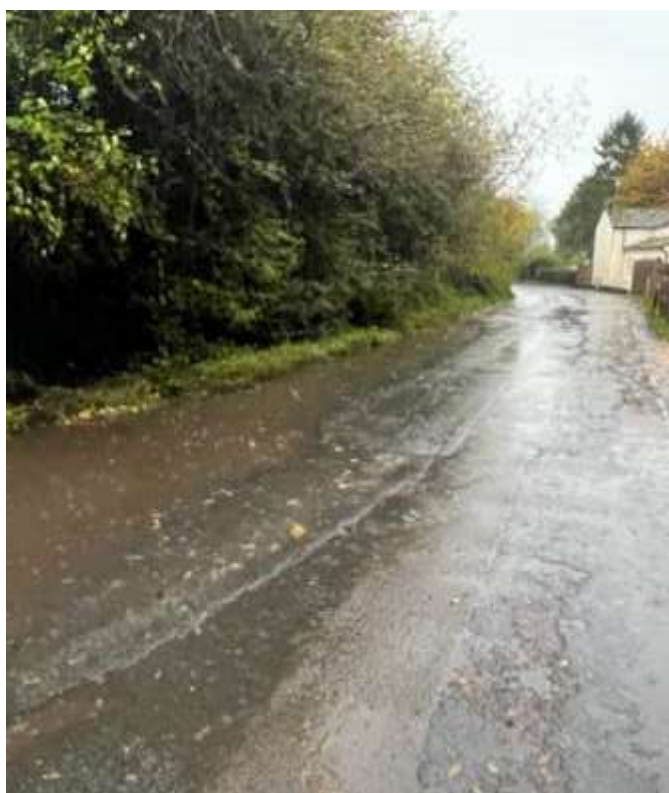
Approaching the bends from the north (left) - the standing water has, in the main, travelled down the eastern side of the carriageway from the Supermarine turn without being able to enter the ditch network.

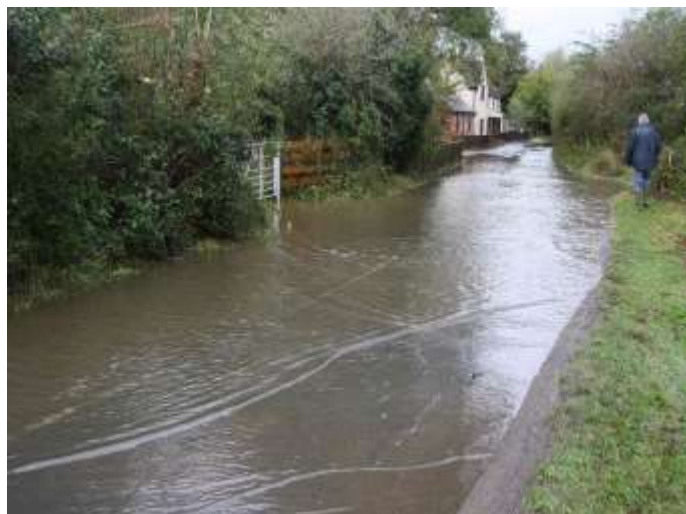
Approaching the Bends from the south (below) shows the extent of carriageway flooding south of the Bends.

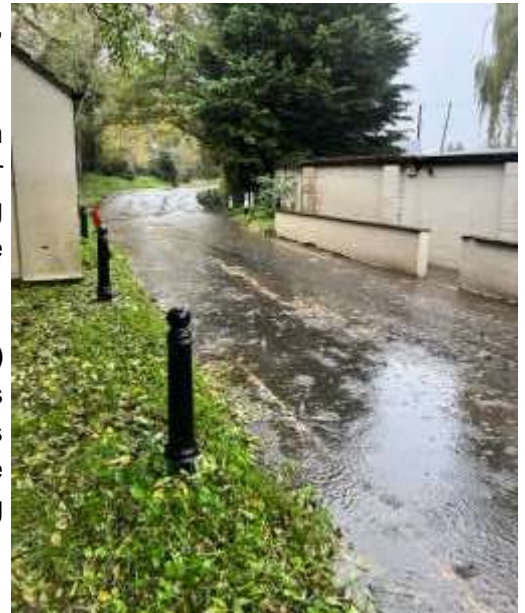
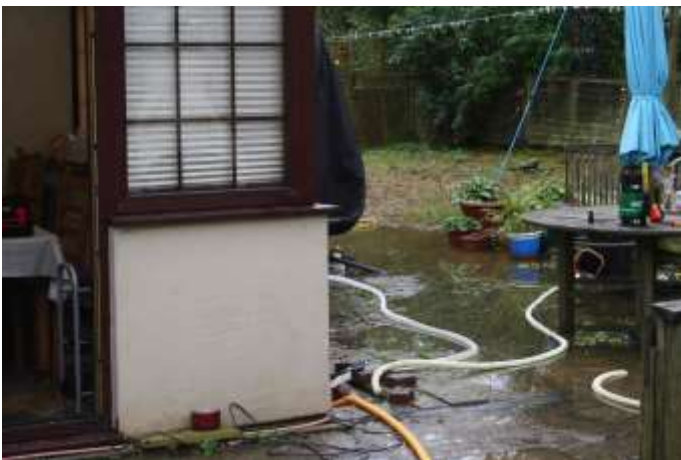
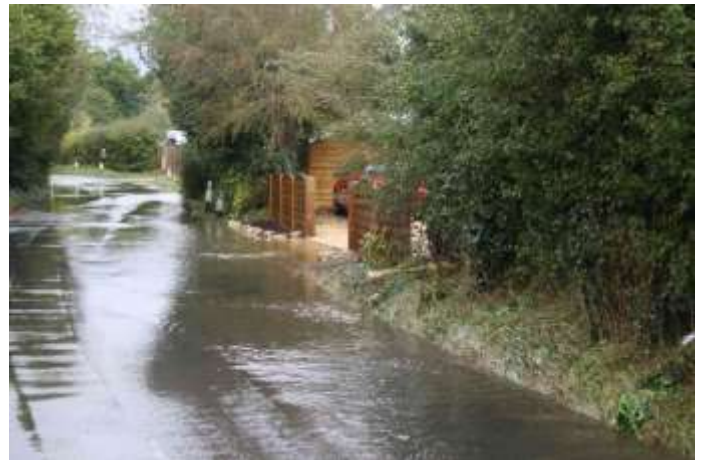
The photo (right) was taken from the front drive at **'Sunleys'**, looking across to **'Ashdene'**.

Residents at Sunleys experience flooding coming from the South Marston Park lagoon, but they also point to the impact of water constantly being thrown up onto their property by traffic passing through the standing water on the road. All these properties are very close to the carriageway.

The resident pumping out his kitchen and at **'My Home'** (below) considers his flooding is entirely due to the brook at the rear of his property needing clearing and that willow growth further down was restricting the water from flowing away. He also noted the storage lagoon upstream was not adequately maintained - it was becoming overgrown and silted and was no longer functioning as it should.

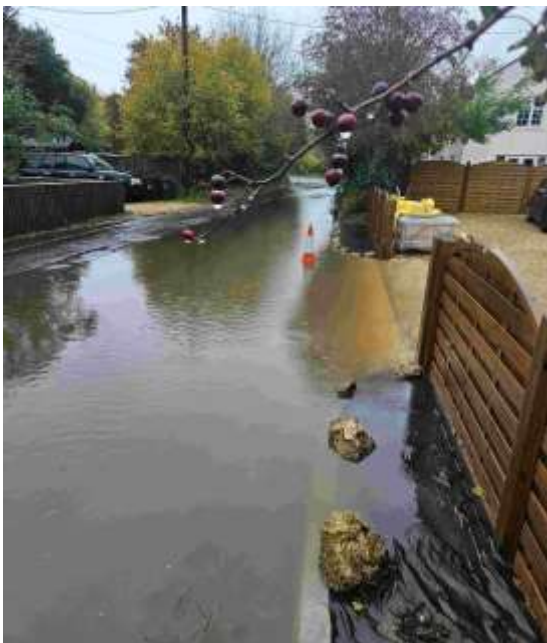
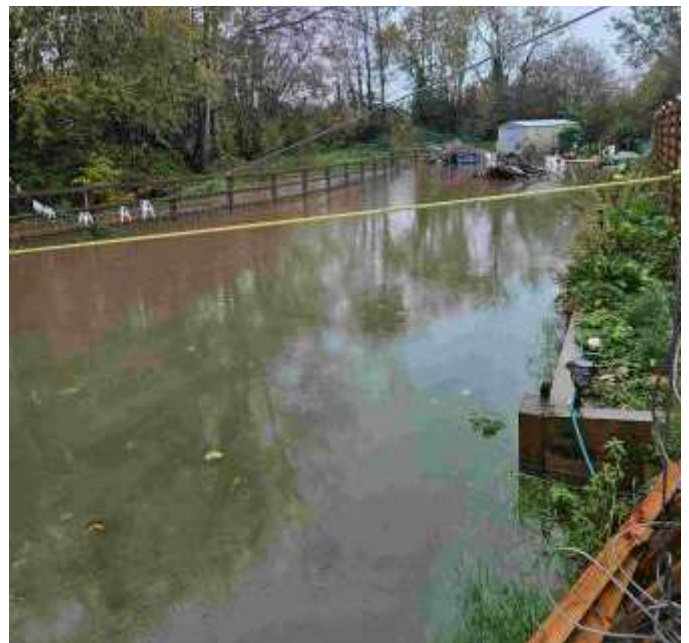
**'Southview'** on the east of the bends is flooded both back and front (below). The road is under water (left) and the flooding in the back garden was very deep (right). The shed at the end is on 4ft. stilts.

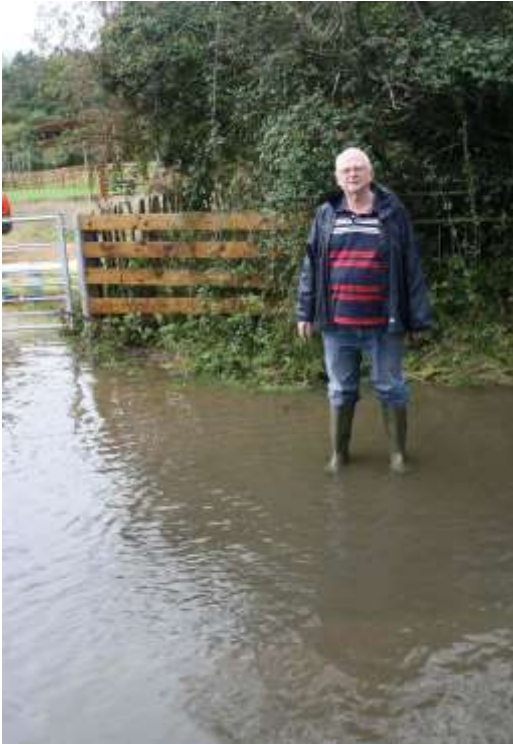
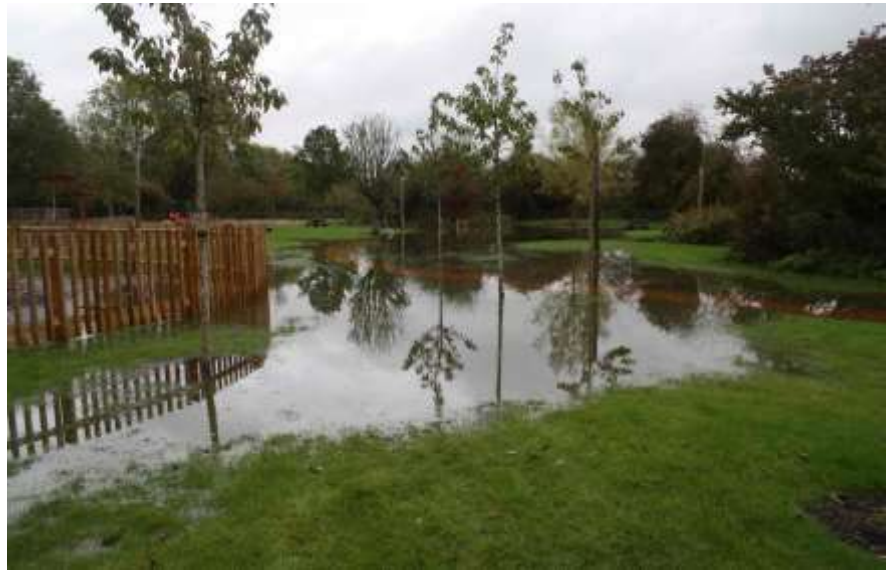
The Highworth Road carriageway is very much under water at the maintenance entrance to the Honda Memorial Gardens, just south of the Bends. Below, the garden area is completely water-logged - this is the landscaping, not the pond!

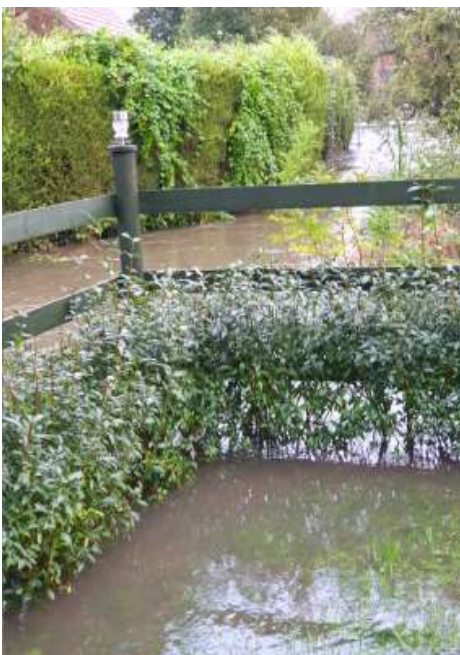
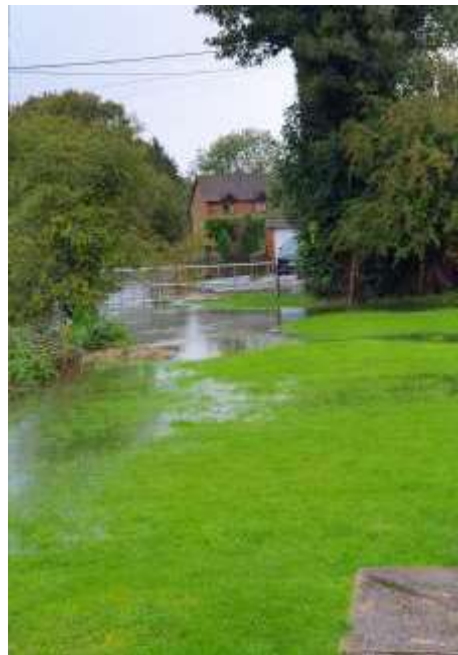
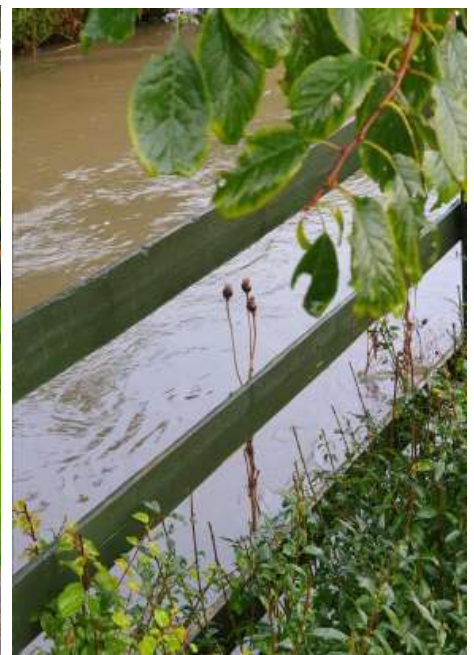
The bungalow (4 Chapel Lane) next to Pigeon Farm had water overflowing into the back garden. The flood to the front of the bungalow was equally worrying. The speed of flow is visible on the right.

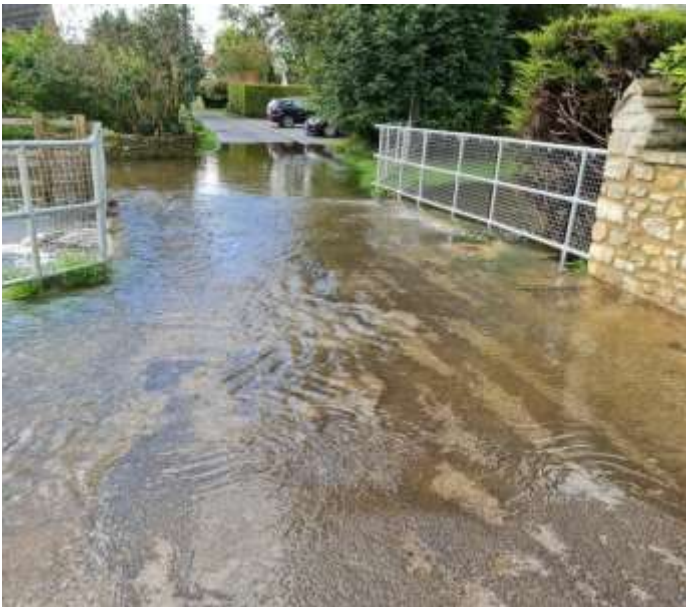
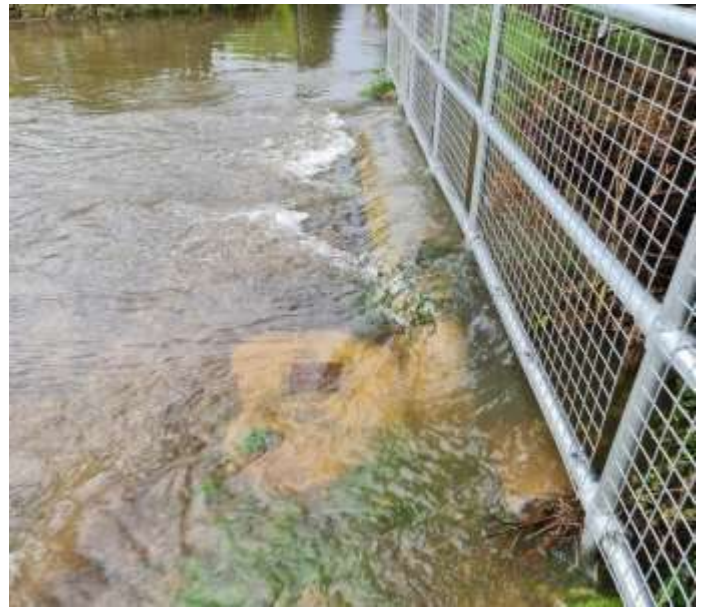
The Brook flowed over Chapel Lane bridge, flooding the roadway and nearby properties affecting a number of residents. One resident reports that, for the first time since 2007, they experienced water in the ditch which runs directly behind Pigeon Farm and Pigeon Cottages. This water backed up because it could not enter the Brook due to the high water level. They were therefore threatened on 3 sides: the front where the water gushed over the bridge flooding the lane and the land beyond, and even more so at the rear by 2 ditches overflowing with fast running, high volumes of water.

The Chapel Lane bungalows are owned by the Borough and occupied by vulnerable residents. Toilets in numbers 1, 2, 3, and 4 threatened to overflow. There was no flushing, just in case.

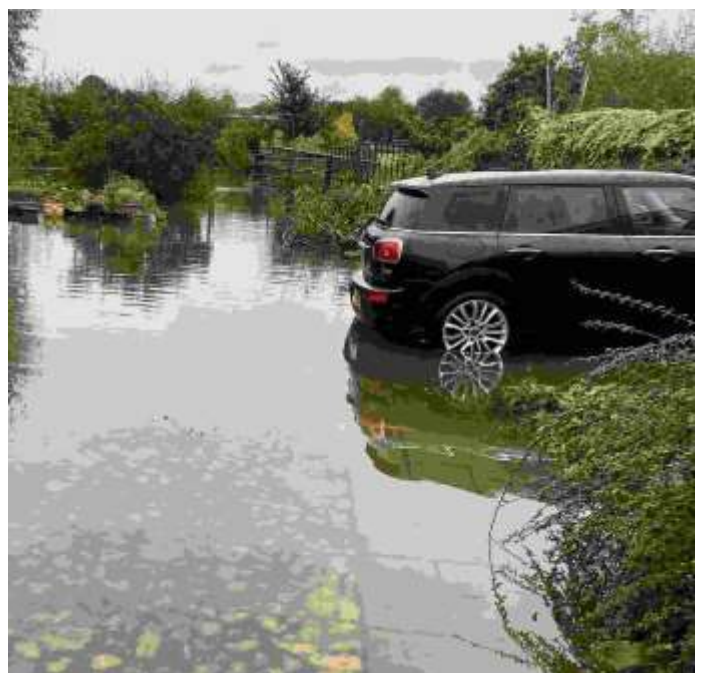
**Church Farm House**, a listed building, is located very close to the Brook. It suffered serious internal flooding in 2007.

The photo shows the flooded former farmyard which is adjacent to the main house.

The sewer spills out and the water level rises in the downstairs toilet.

Since the October storms, the resident has put in increased protective measures, but the property remains vulnerable. Pumps have been used at this and other houses neighbouring the Brook.

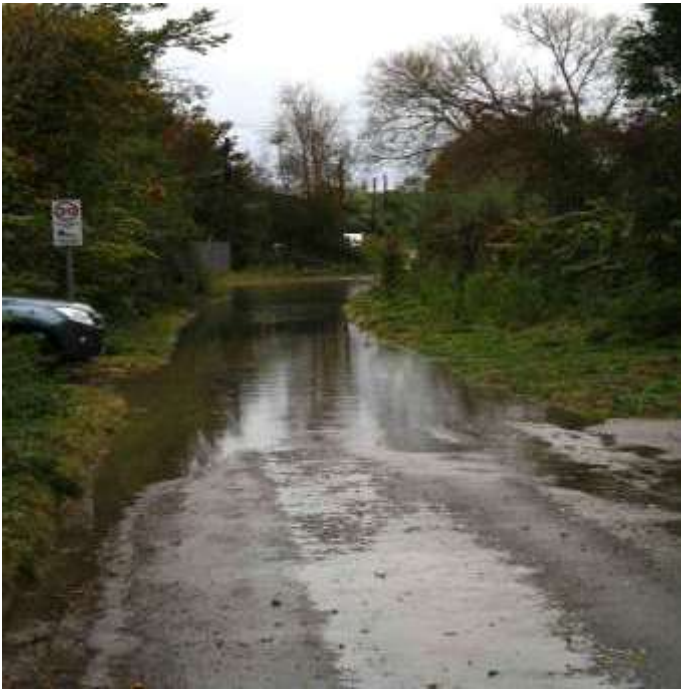
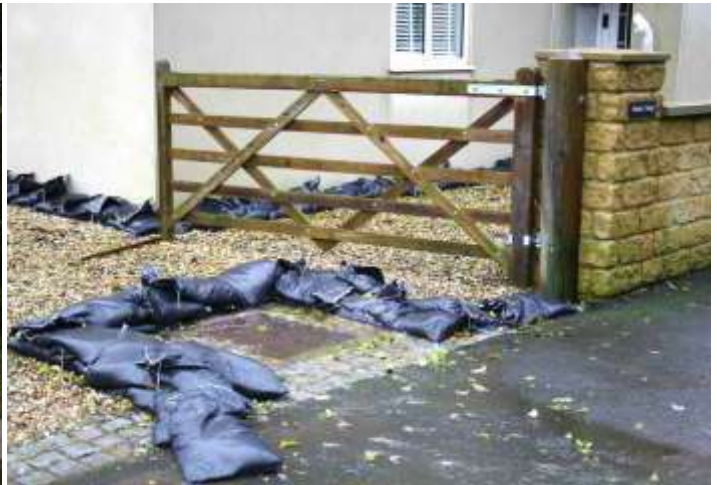
**Meadow Cottage** on the left, looking eastward up Nightingale Lane towards the pumping station.

There are major local concerns about the efficiency and sufficiency of the pumping station so close to South Marston Brook, compounded by the ever - increasing frequency of Thames Water pumping vehicles appearing on the scene.

At Meadow Cottage (right), the mains sewer was overflowing on their driveway. When the Thames Water personnel lifted the manhole, a geyser of effluent erupted three foot into the air.

The Nightingale Lane pumping station cannot cope and foul water backs up several times a year. Significant development is planned for the village itself e.g. at Crown Timber and Keypoint and we require assurance that the system's capacity will be increased to cater for this.

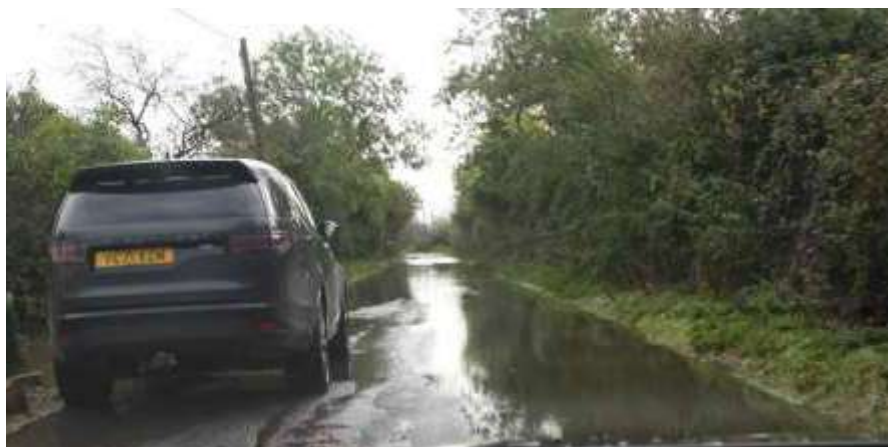
From Manor Cottages looking south towards Rowborough Lane (right). It looks just passable here.

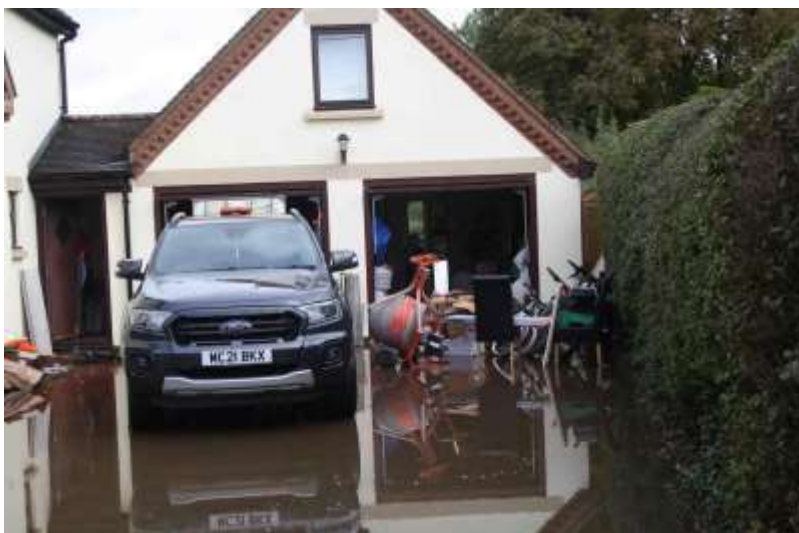
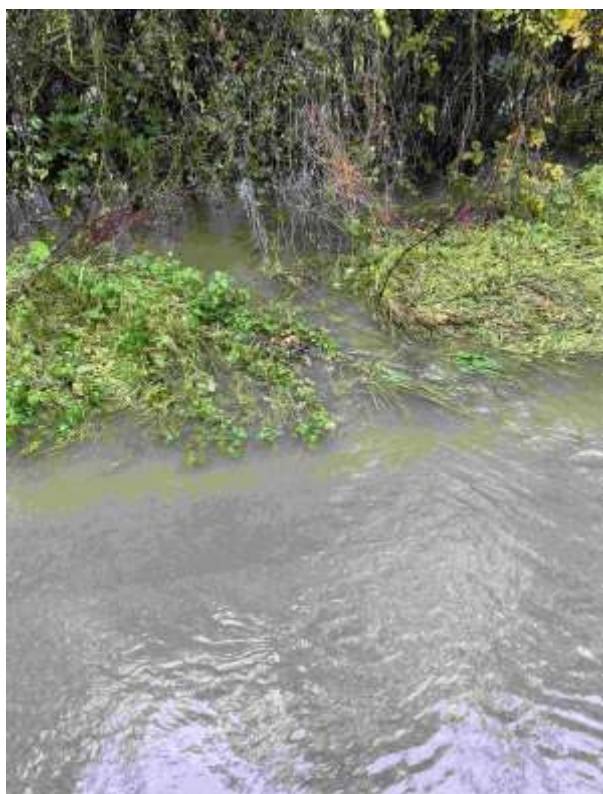
Beyond Manor Cottages on Old Vicarage Lane, **Rowborough House** suffered its first flooding ever with water running down from the east from South Marston Brook and adjacent fields, to arrive behind the house and into the garage. This was clearly identifiable by the smell of slurry from the fields.

The resident in Rowborough House also pointed out that they were under threat from the west because of the surface water collected on the fields to the west of Old Vicarage Lane. With no maintenance or clearing of the ditch, the water was overflowing onto the road and across to the houses. It was simply standing rather than flowing away, due to the blocked ditch.

Photo (left) shows water pouring off the fields to the west of Old Vicarage Lane onto the roadway.

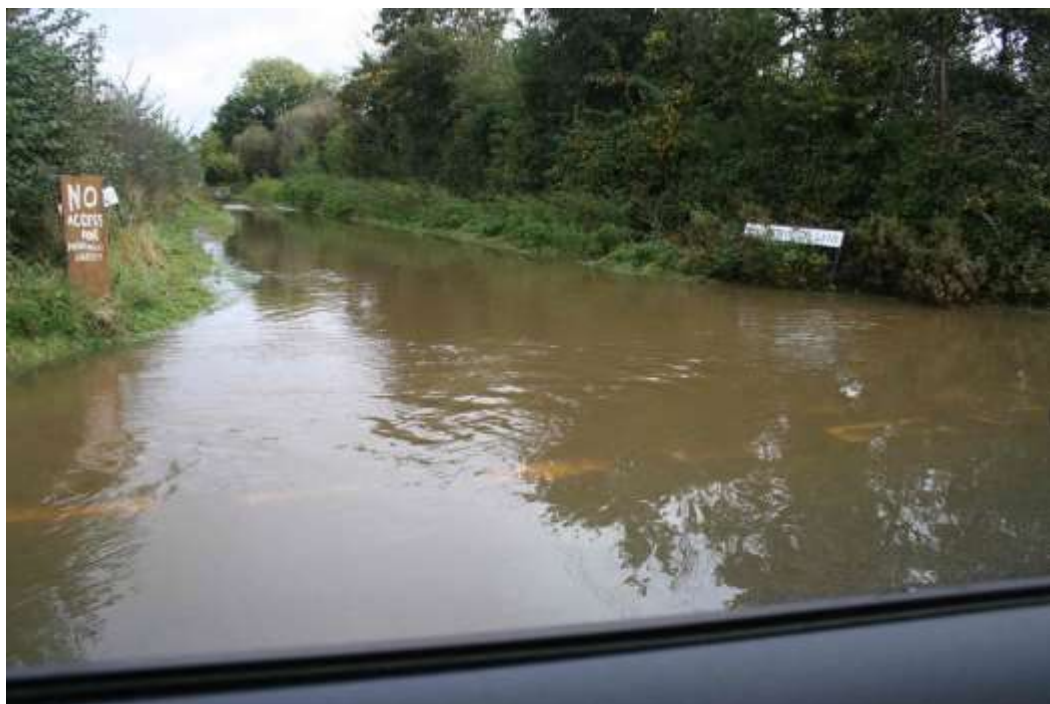
Further south, running east from Old Vicarage Lane, Rowborough Lane was impassable.

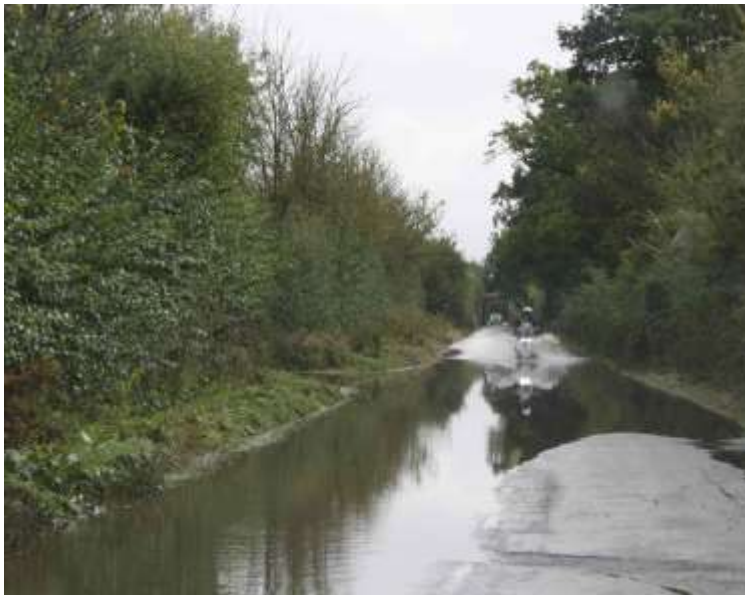
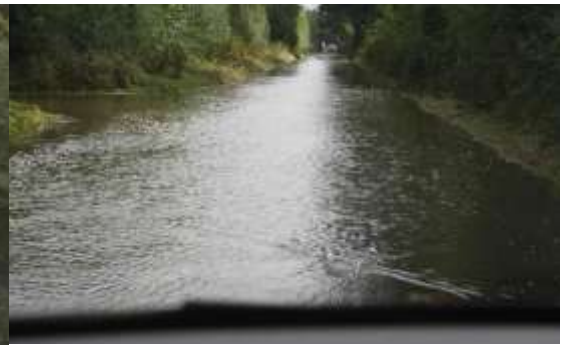
**The junction with Rowborough Lane looking towards the railway bridge.**

A Range Rover or a motorbike could just get through – but the Tesla driver sensibly turned round without trying it.

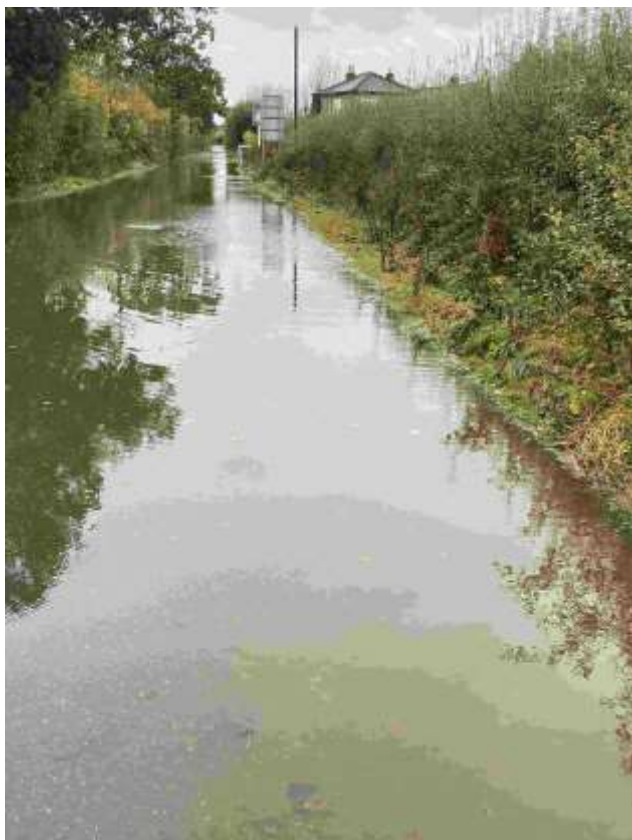
Looking north from the railway bridge towards the Carpenter's Arms

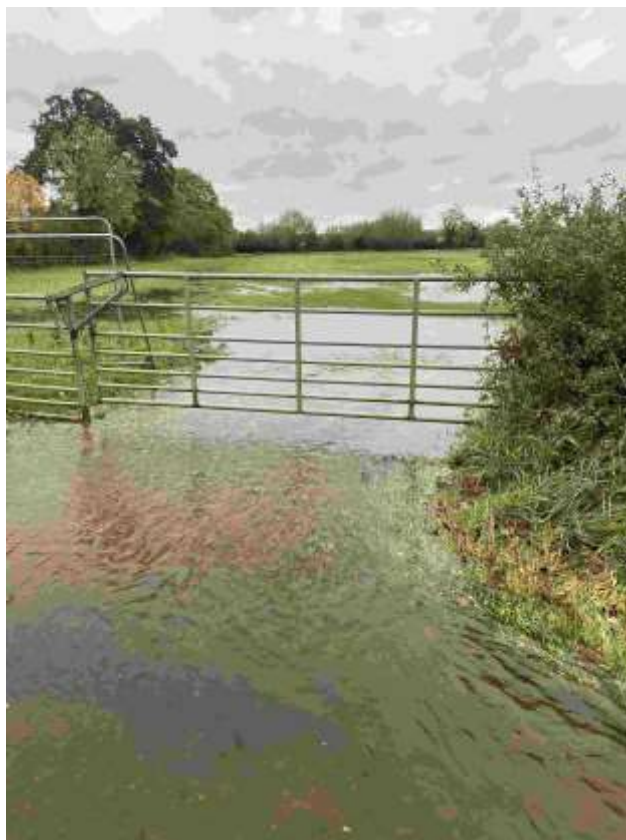
Water flooding east into the field between the culvert and the railway bridge

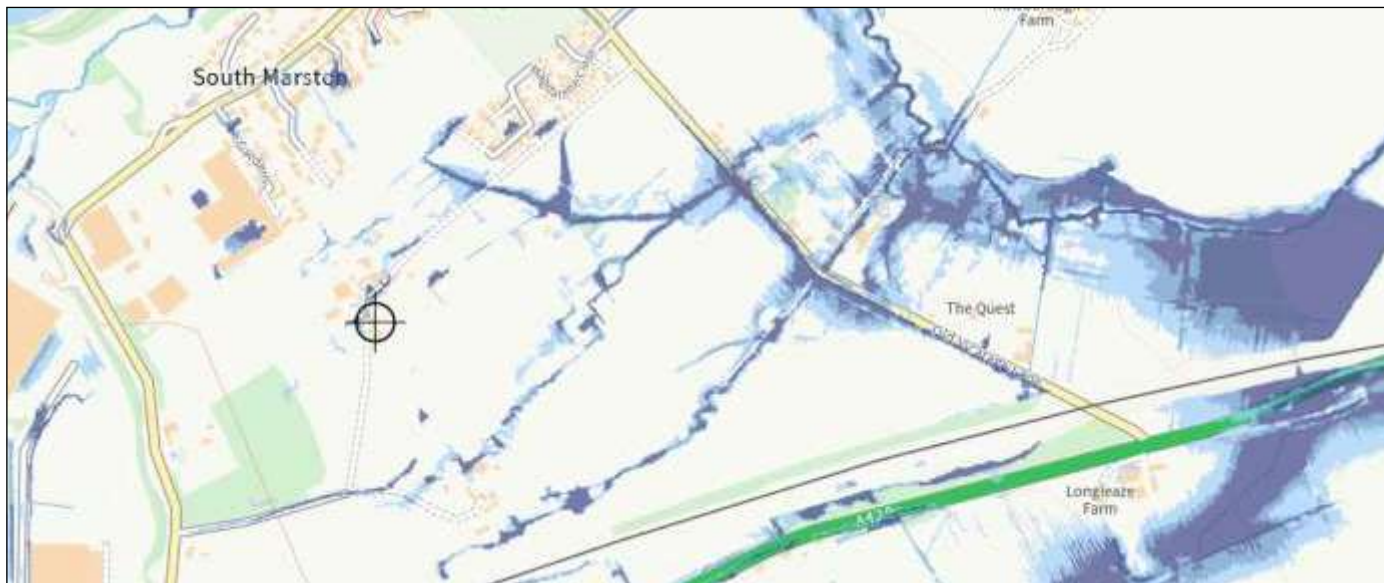
The west to east flow across the village is officially accepted as significant (see EA map above). The photo (right) shows the water collecting on land immediately south of Magdalene Close, an area already designated for housing.

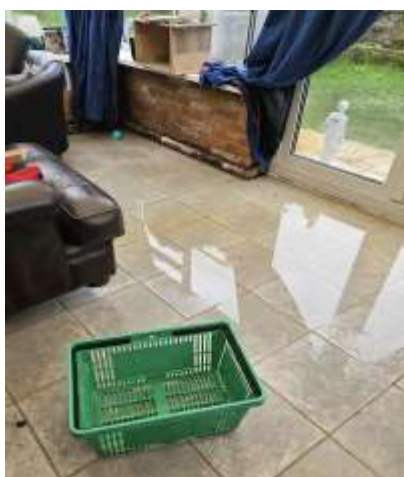
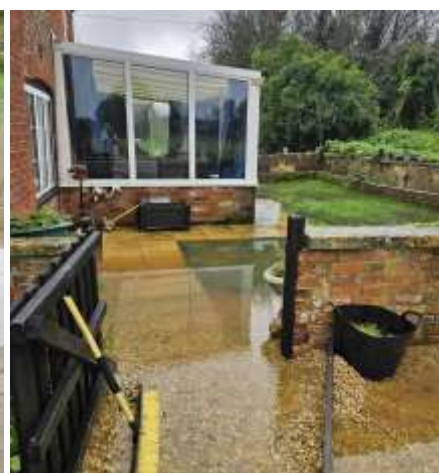
**Flooding at Red House** - Red House has had past experience of internal flooding. During the October storms, flood water surrounded the property, and flooded inside the house.

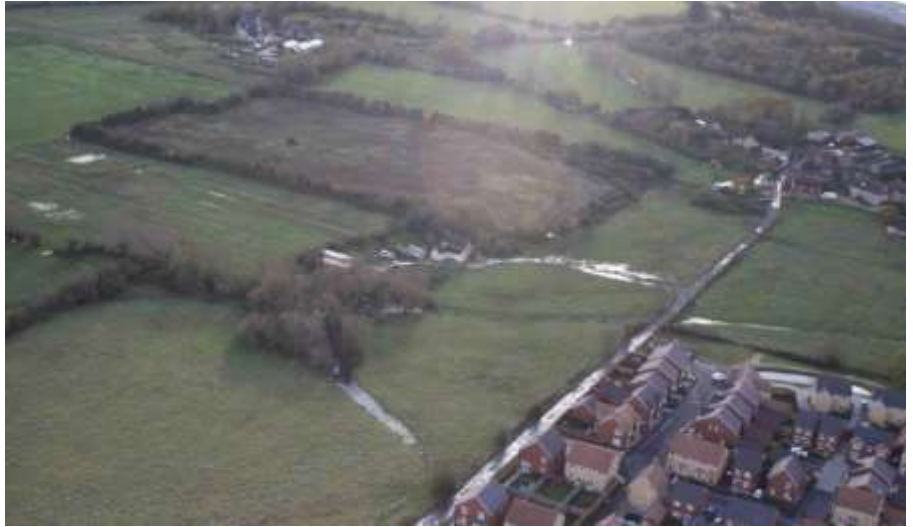
Photo 1 shows Bridleway 4 (B4) running up to Manor Farm, with Magdalene Close bottom right. The current drainage 'swale' is shown entering on the right, crossing under the track - this will be deepened by the HHT development. On the southern side of B4, this proposed swale will run south of Red House (roughly behind the clump of trees) to reach the planned storage basin opposite the Carpenters Arms. Land between this swale and Old Vicarage Lane will be major new housing areas.

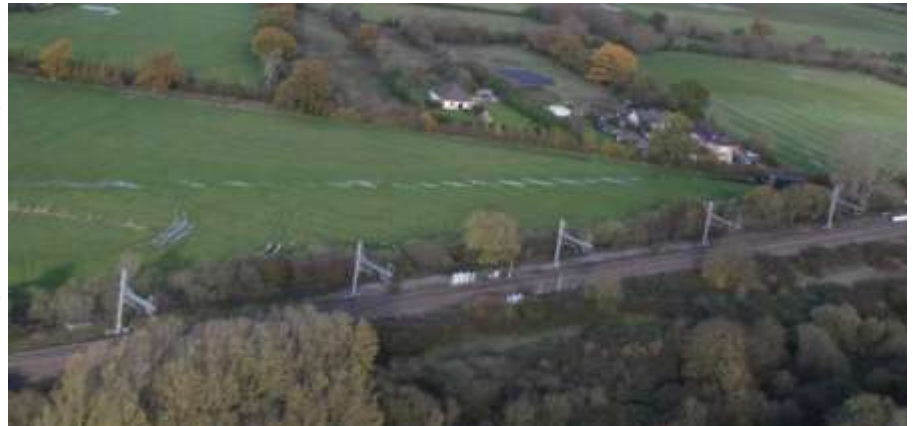
Photo 2 clearly shows the current route of surface water from the end of Morses Lane (off to the left) across to the Carpenters Arms (right), alongside the railway. The planned storage basin is where it approaches Old Vicarage Lane.

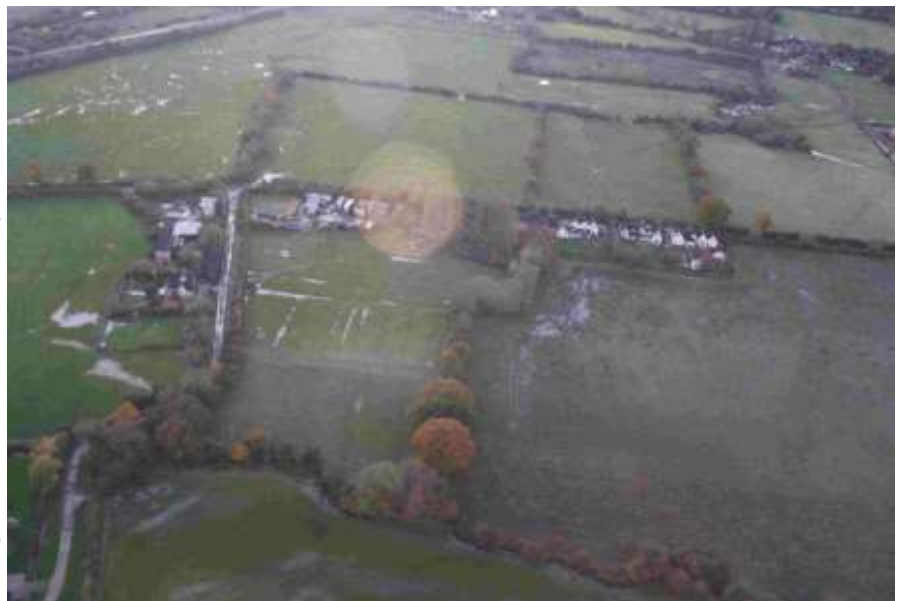
Photo 3 shows the field network either side of Old Vicarage Lane with Rowborough Lane running up to Rowborough Farmhouse bottom left and the railway top left.

South Marston Brook is the bank of trees across the bottom. It shows the most vulnerable flooding areas both sides of Old Vicarage Lane.

Note there is a landscaped green area planned for the land between Old Vicarage Lane and the Brook, providing additional scope for swales to prevent overloading the capacity of the Brook itself.
